QUINQUENNIAL INSPECTION REPORT

ST. MICHAEL & ALL ANGELS

COMPTON MARTIN

September 2019

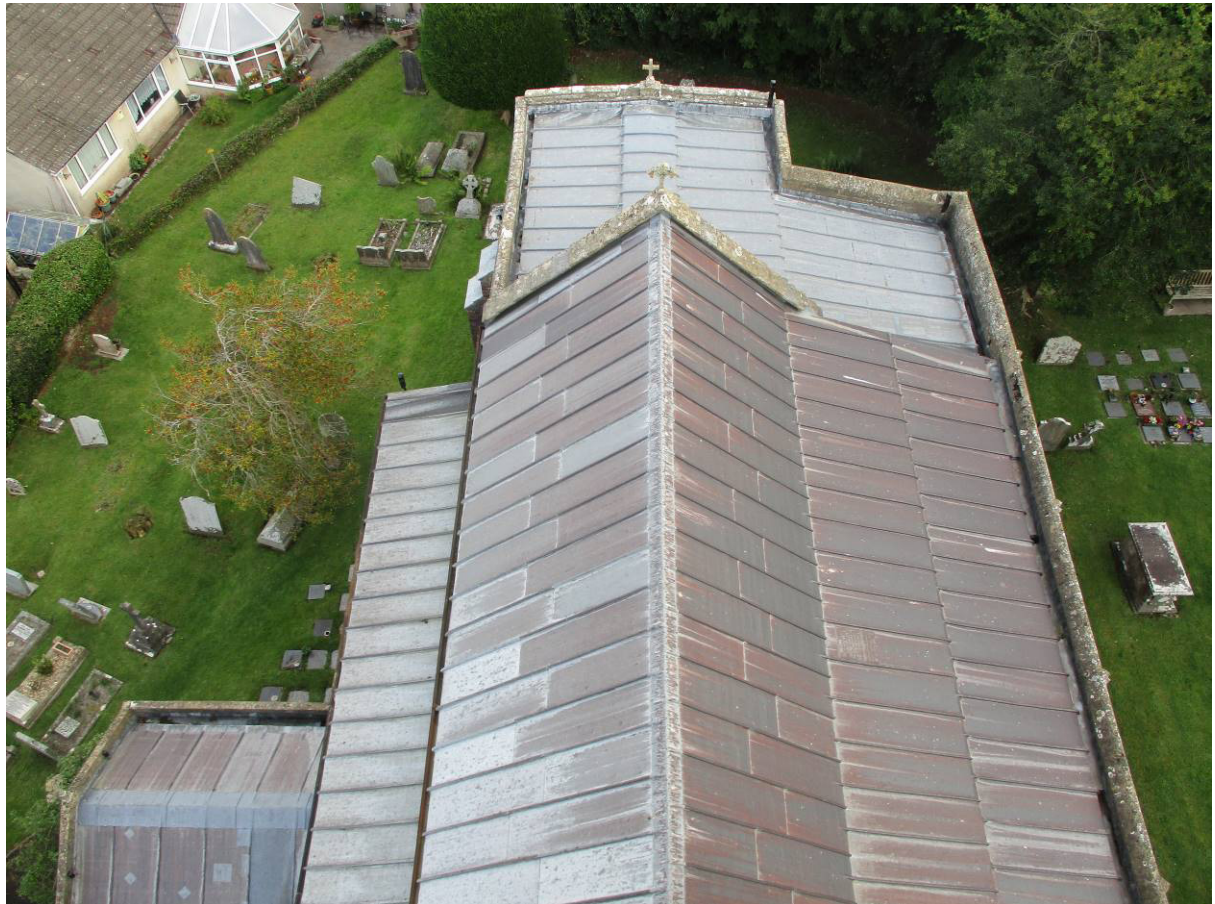
Fig.6 The roof of the nave, chancel, organ chamber, aisles and porch seen from the tower.

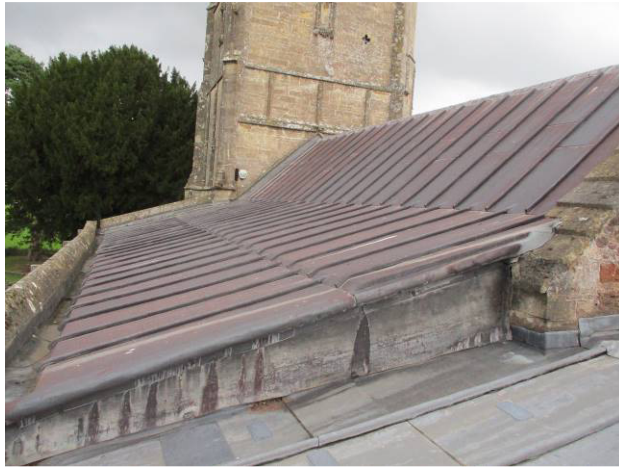
The south slope of the nave is covered with lead sheeting, which falls on to the roof of the south aisle (see fig.7). The lead sheeting to both roof coverings has hollow rolls and the south aisle roof falls to a lead parapet gutter. The roof coverings and lead flashings are in good condition.

Fig.7 South aisle & nave roof.

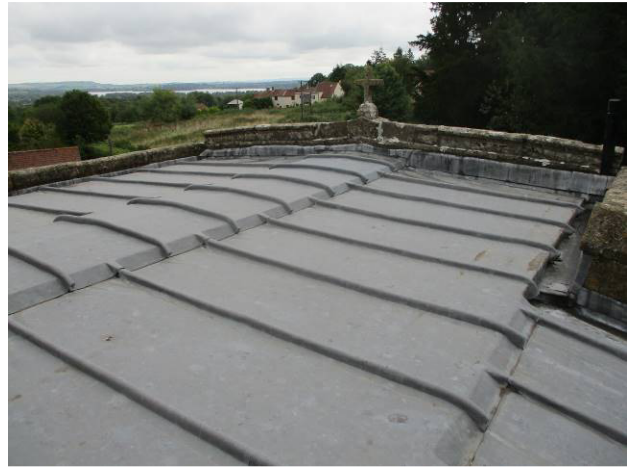
The chancel roof is covered with lead sheeting, which falls to a parapet gutter to the north and south sides (see fig.8). The lead sheeting is in good condition, but there is some sign of failure to the mortar pointing to the east flashing (see fig.9).

Fig.8 Chancel roof.

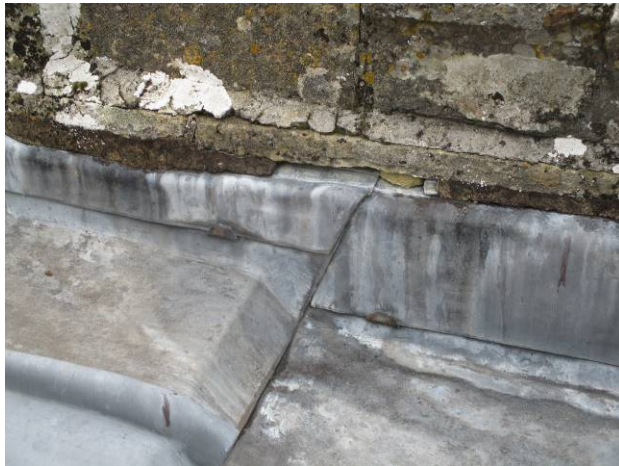
Fig.9 Defective pointing to chancel flashings.

- 2.1.1 Repoint flashings to east side of chancel roof. **B**

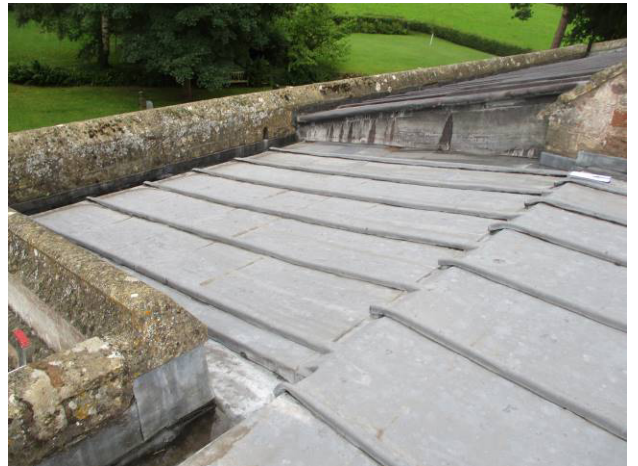
The organ chamber roof is covered with lead sheeting with hollow rolls, falling to a lead-lined parapet gutter to the south side (see fig.10). It is in good condition. There is some sign of patching to the westernmost sheets, along with some signs of thermal movement. This does not give rise to concern at this stage.

Fig.10 Organ chamber roof.

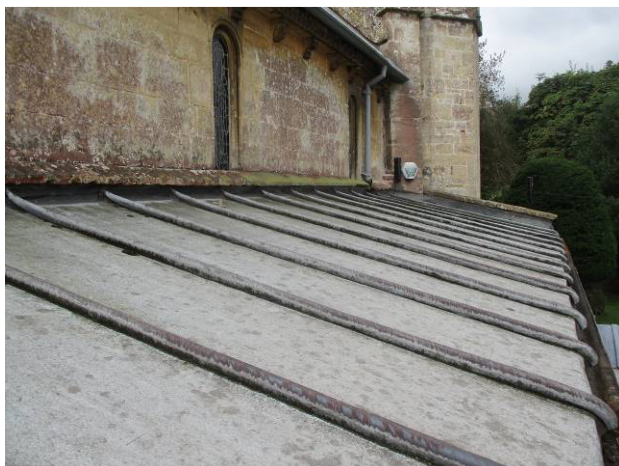
The roof of the north aisle is covered with lead sheeting with hollow rolls falling to an ogee, cast-iron gutter (see fig.11). There is some sign of creep, but the lead sheeting is generally in good condition.

Fig.11 North aisle roof.

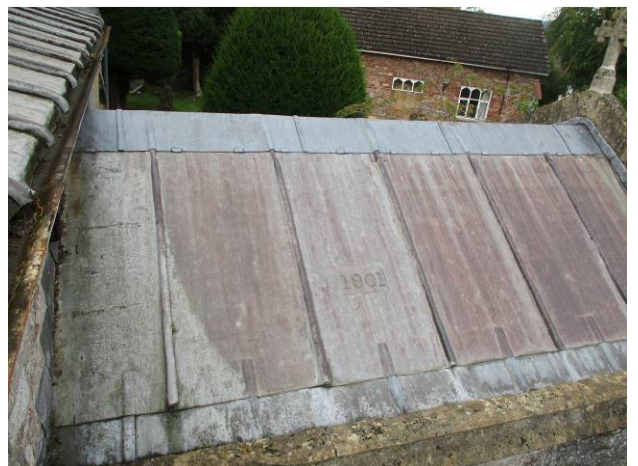
Fig.12 Porch roof.

The north porch is covered with wide sheets of lead (dated 1901) falling to parapet gutters on the east and west sides (see fig.12). The lead sheeting has been patched

in a number of locations and the lead ridge appears to have been renewed in recent years. The roof appears to be in a weathertight condition.
